United States Steel Corporation

# **Resolution Manual For Metal Building Construction**

## **Job Site Imperfections**

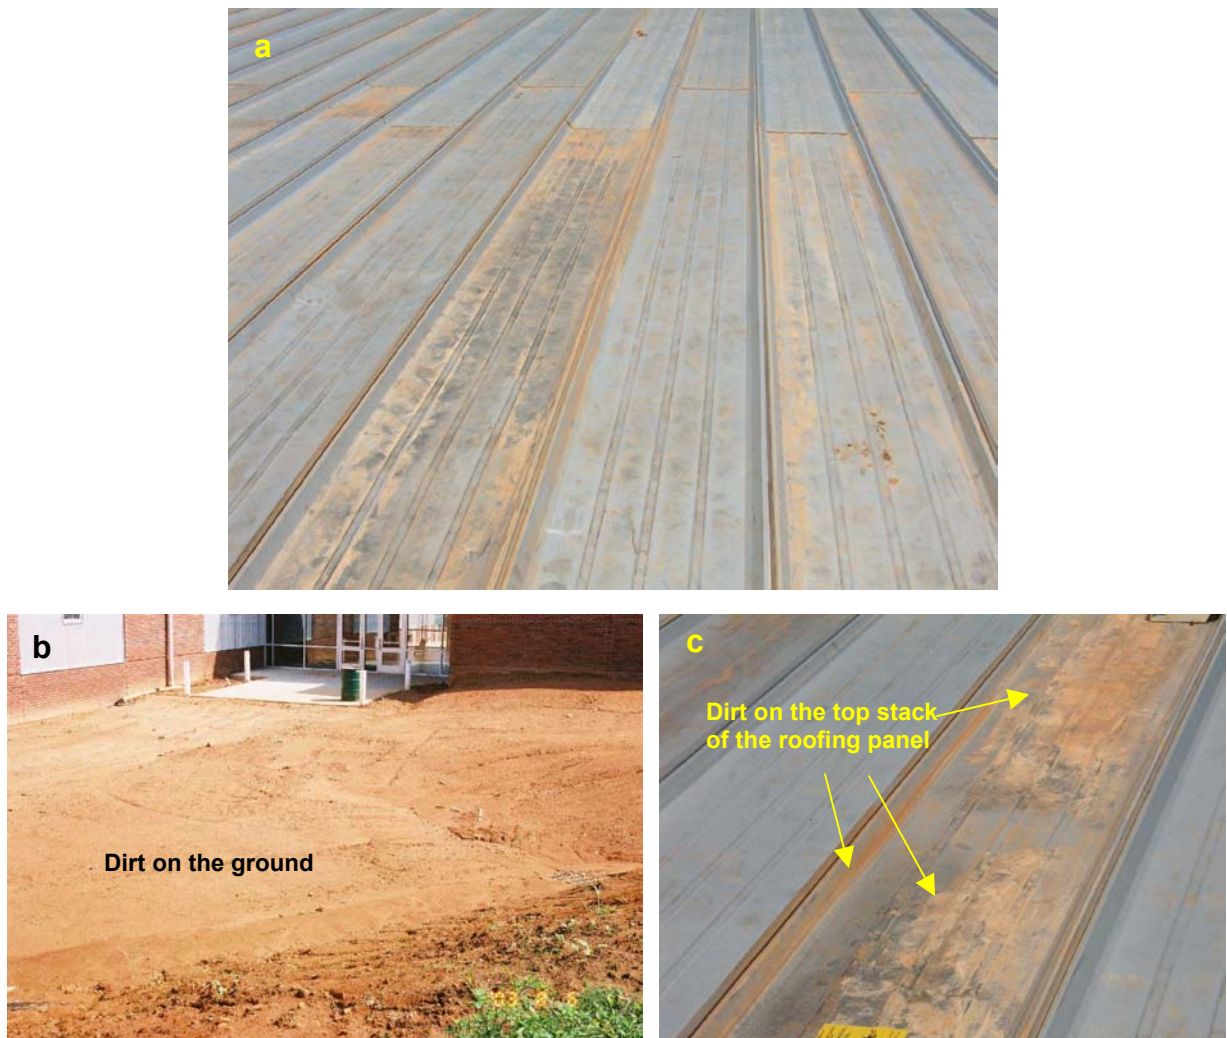
Staining and an inconsistent appearance of bare GALVALUME<sup>®1</sup> Coated Sheet Steel roofs can be caused by dirt being introduced by either foot traffic and/or poor storage practices. The example in Figure 1 showed that the dirt on the roof (Figure 1a) matched the dirt on the ground (Figures 1b). The dirt was concentrated on the roofing panels on the top of the stack (Figure 1c) and transferred to the other panels by construction workers walking on the roof. If the dirt is not cleaned immediately after installation, it will cause staining and an inconsistent appearance to the roof, and possibly cause premature corrosion by trapping the moisture on the roof. Therefore, dirt and other debris should be cleaned immediately after installation.

Figure 1. Photographs of stains and inconsistent appearance of a bare GALVALUME<sup>®</sup> roof (a), dirt on the ground at a building site (b), and dirt concentrated on the roofing panels on the top of the stack (c).

The best way to avoid staining of panels is to maintain proper storage and handling practices during the entire construction process to avoid dirt getting on the panels in the first place. Annual washing of the building is recommended to maintain the overall appearance of the building. The useful life of the roof will also be extended by removing dirt and other moisture trapping debris, which can cause premature corrosion.

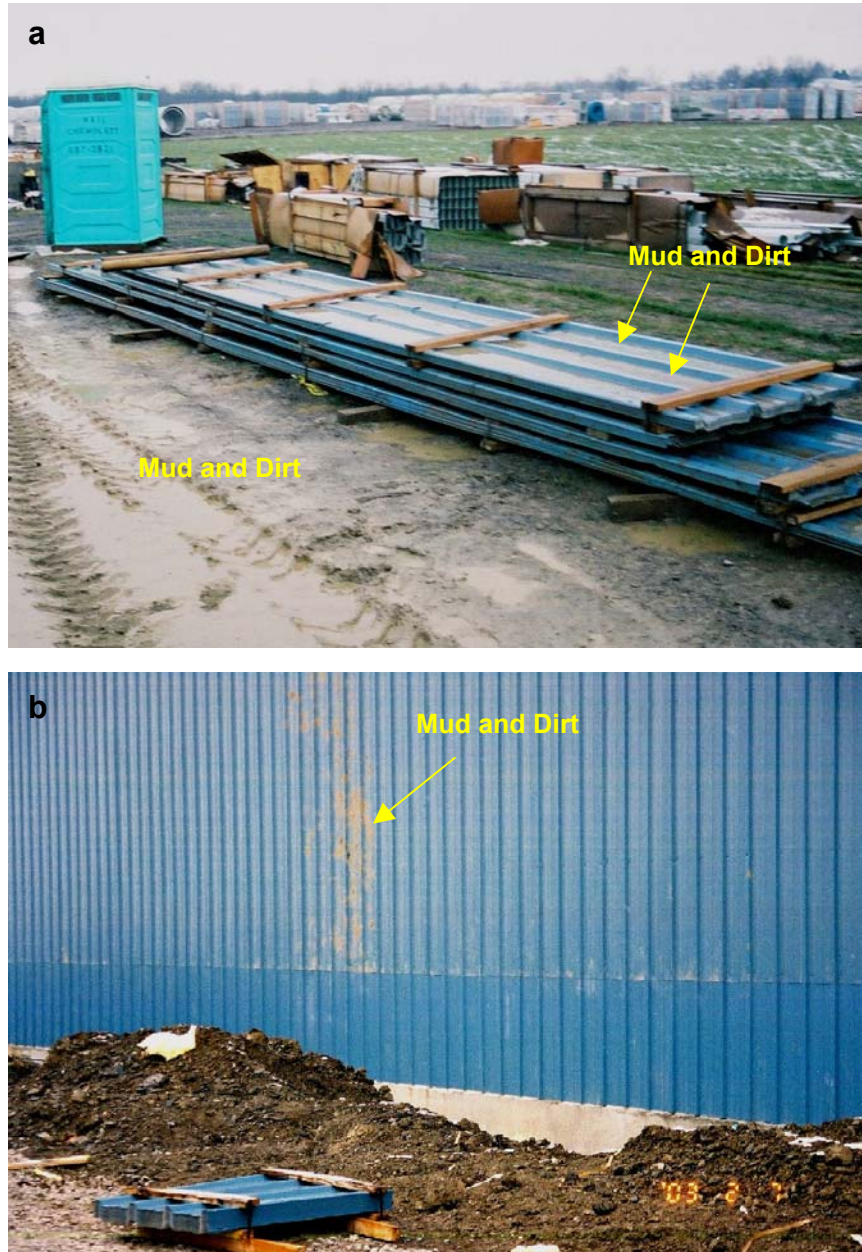
Similar dirt issues can also occur on prepainted panels. Figure 2 shows dirt and mud on the job site was transferred onto the surface of the prepainted GALVALUME® sidings before installation (Figure 2a), and the mud remained on the panels after installation causing appearance issues (Figure 2b). Dirt also concentrated on the top panel of the stack. The best way to avoid this situation is to maintain proper storage and handling practices during the entire construction process to avoid the dirt and mud getting on the panels in the first place. Dirt and mud should be cleaned immediately after installation.

Figure 2. Photographs of mud and dirt on the prepainted GALVALUME® siding panels (a) before and (b) after the installation.

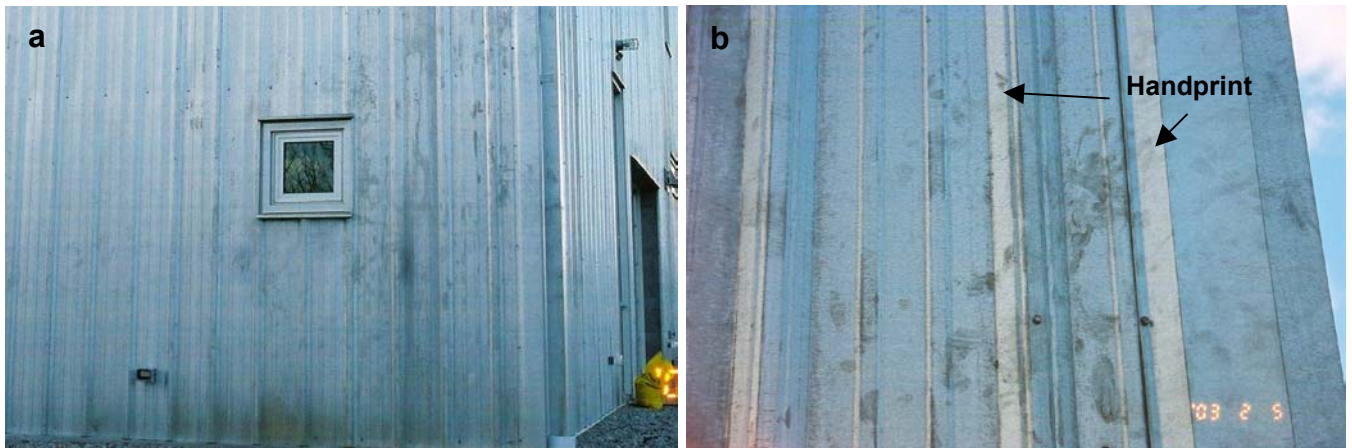
Hand and palm prints on bare galvanized and GALVALUME® panels are the likely result of not using clean gloves in handling the panels during installation. Dirt, oil and perspiration have been shown to be detrimental to the appearance of bare coated products, such as galvanized and GALVALUME® Coated Sheet Steels. Figure 3 demonstrates the results of poor handling practice during the installation of bare GALVALUME® siding, which left handprints on the siding. Figure 4 shows the non-uniform darkening smudge marks due to excessive abrading of the surface of the roofing panels and footprints on the GALVALUME® roofing panels. Panel-to-panel contact, walking on the panels, and not using clean gloves can also cause poor appearance. The contractor should be cautioned, prior to installation, to avoid poor handling practices, since the contractor is ultimately responsible for these imperfections. However, it should be noted that the darkening or smudging does not affect the corrosion performance of the panels.

Figure 3. Photographs of handprints and smudge marks on bare GALVALUME® siding (a), and close-up view (b).

Instead of bare GALVALUME® Coated Sheet Steel, ACRYLUME®<sup>2</sup> Coated Sheet Steel can be used, which provides better hand, footprint and smudge mark resistance. ACRYLUME® Coated Sheet Steel has a very thin clear acrylic coating over GALVALUME® Coated Sheet Steel. The acrylic coating also provides better protection during storage.

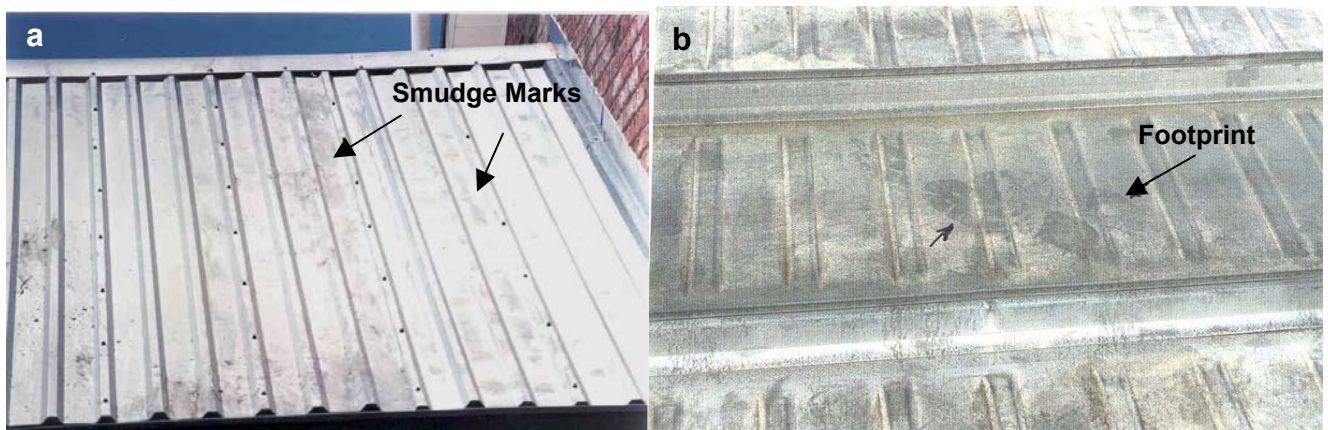
Figure 4. Photographs of smudge marks (a) and footprints (b) on bare GALVALUME® roofs.

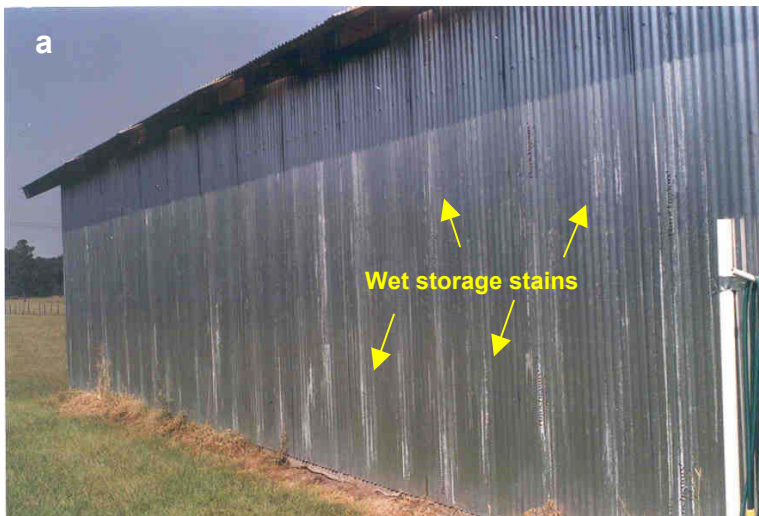
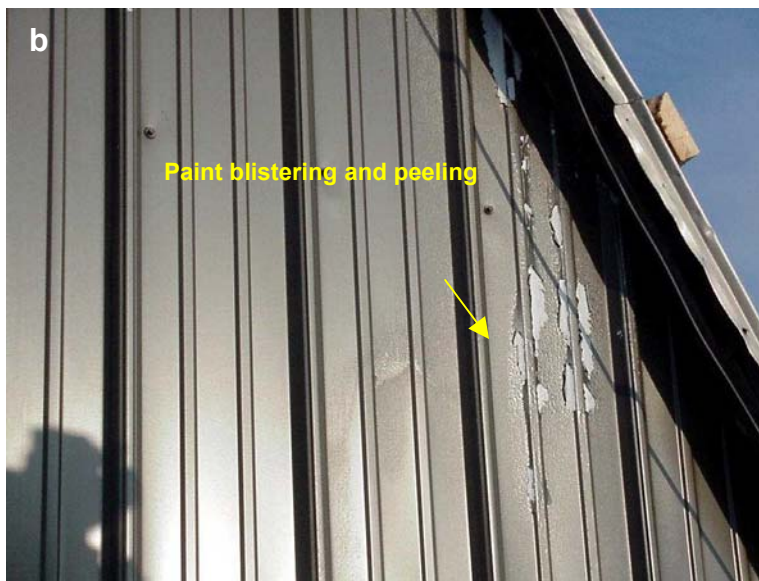
Figure 5. Photographs of wet storage stains on bare galvanized steel siding (a), and wet storage causing paint blistering and peeling on prepainted galvanized steel siding (b).

Figure 5a shows white rust and storage stain, on the bare galvanized steel. Wet storage problems are not limited to bare materials. Prepainted products are also susceptible to wet storage issues, which occur when the panels are in bundle form and exposed to moisture, such as the siding panels shown in Figure 5b. The difference with painted panels is that the corrosion starts underneath the painted surface and first appears in the form of blisters or a rough surface, which eventually progress to the point at which the paint peels from the galvanized steel panels. For more information, see National Coil Coater's Association Technical Bulletins at <http://www.coilcoating.org>.

Wet storage stain can be easily identified. Typically, there is no orientation to the staining pattern, but the white rust or the stain patterns should be on both sides of the panel. If the panels are still stacked in the bundle, the pattern should be in a mirror image on the bottom side of the panel to the top side of another panel that it was in contact with.

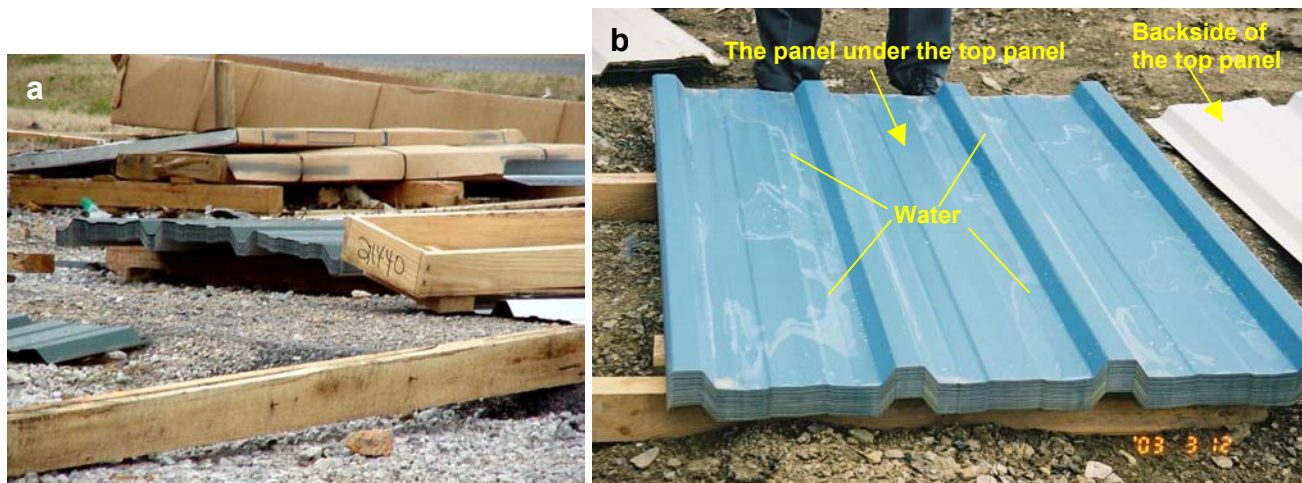
Wet storage conditions are frequently found on job sites where panel bundles are improperly stacked (Figure 6a), or are laid flat on the ground, without protection (Figure 6b). Water can penetrate between the panels by condensation, or capillary action, creating wet storage conditions, which cause paint blistering and substrate corrosion on the prepainted panels, while causing storage stain on the bare hot dip galvanized or GALVALUME® Coated Sheet Steel. Therefore, panels and accessories should not be stored in wet conditions. Care should also be taken to avoid handling damage on the job site. The panel storage condition shown in Figure 6a could potentially create a wet storage condition and cause premature corrosion. It could also cause damage to the panel before installation.

Figure 6. Photographs of panel bundles improperly stacked at the job site (a), and water on the surface of a panel that was in the bundle under the top panel (b).

Bundles should be positioned with one end slightly elevated to permit runoff of moisture from the top of the bundle or from between nested panels. Water-resistant paper will not necessarily provide long-term resistance to moisture penetration from puddled water on top of the bundle. A waterproof cover should be placed over the bundles while allowing for air circulation under the cover (see Figure 7). More information can be found in U. S. Steel Technical Bulletins at <http://www.ussconstruction.com> or in the National Coil Coater's Association Technical Bulletins at <http://www.coilcoating.org>.

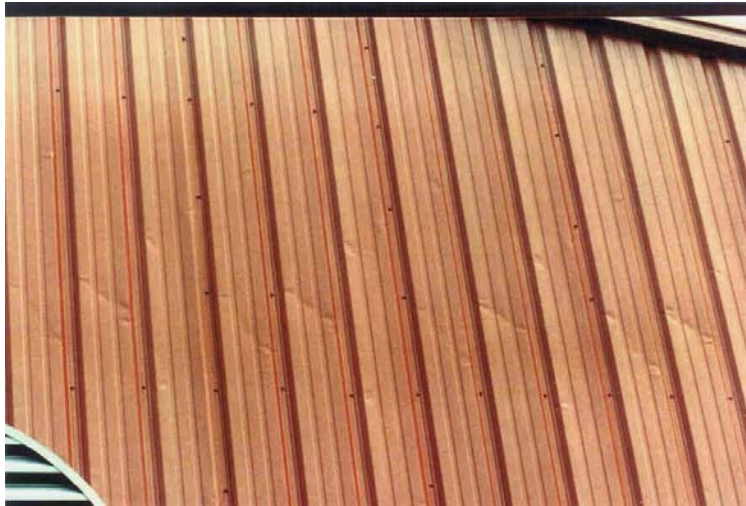
Damage related to the transit or handling of the bundles should be recognized and avoided at the construction job site. This kind of damage can be identified on the panel prior to installation. There is usually a pattern to the damage, which is typically isolated to the major ribs on a given panel. The damage may also be associated with loose banding or poor packaging practices, transit, storage and/or the handling of panel bundles prior to installation. The damaged panels should not be installed since the damages will have potentially adverse effect on the performance of the panels.

Figure 8 is an example of transit and handling damage. The pattern of the damage is typical of handling issues while panels are still in bundle form. Regardless of whether the damage was caused by blocking, forklifting or by some other external force, it usually exhibits a repetitive pattern. Nevertheless, the damaged panels should have never been installed. Figure 9 shows other examples. Mishandling of the panels caused paint abrasion damage at the radii of the major ribs in the up-down direction (Figure 9a), which could result in premature corrosion. The scratches on the surface of painted panel caused premature corrosion in the damaged area (Figure 9b).

Figure 8. Photograph of damaged panels on the building's sidewall.

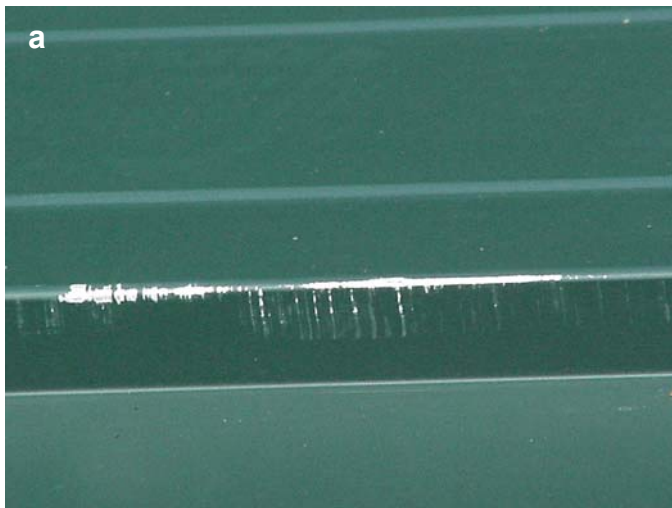
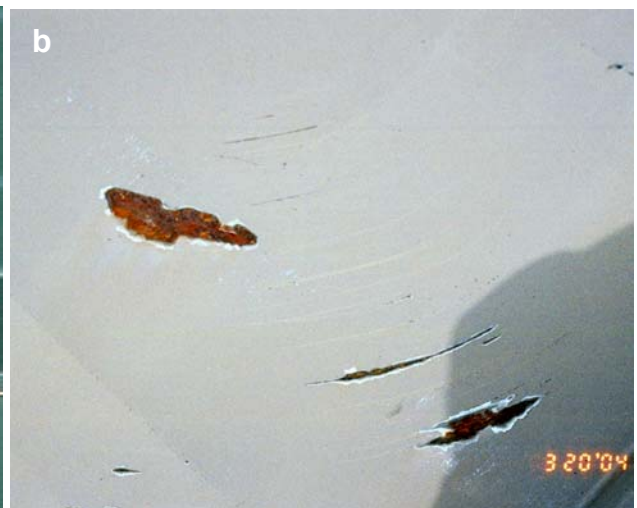
Figure 9. Photographs of paint abrasion damage on the major rib of the panel (a), and scratches on the surface of a painted panel resulted in premature corrosion (b).

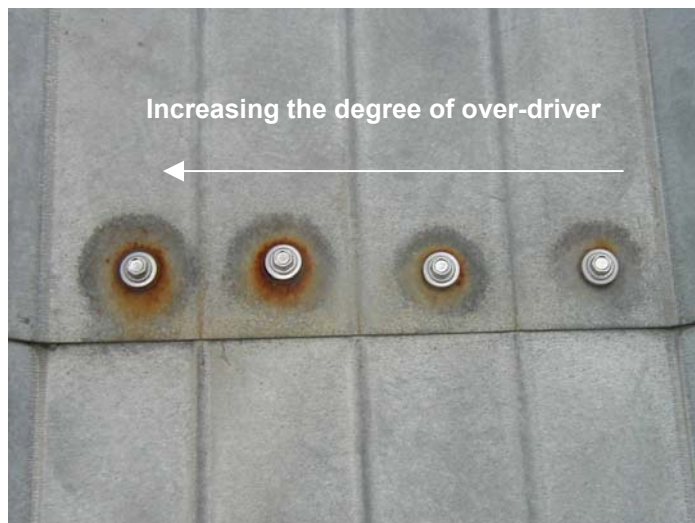
Figure 11. Photograph of the over-driven fasteners. The corroded area around the fastener increased with increasing depth of depression.

Fasteners should be installed properly to avoid being over-driven, under-driven or driven at an angle. Figure 10<sup>3</sup> is a schematic example of the proper and improper installation of fasteners. Properly seated and installed fasteners should be watertight and not allow water to leak or allow water to collect around them. Over-driven fasteners may cause depressions around the fasteners, which can collect water and accelerate corrosion. Therefore, impact-type tools should not be used. Figure 11 is an example of over-driven fasteners. The GALVALUME® material around the fasteners was corroded due to water ponding in the depression. The corroded area around the fastener increased with increasing the depth of the depression. Under-driven fasteners or fasteners that “back out” over time can allow water to leak at fasteners allowing water to saturate insulation causing inside-out corrosion (Figure 12<sup>4</sup>). Driving tools with depth-sensing nose-pieces and suitable speeds can help to avoid these problems.

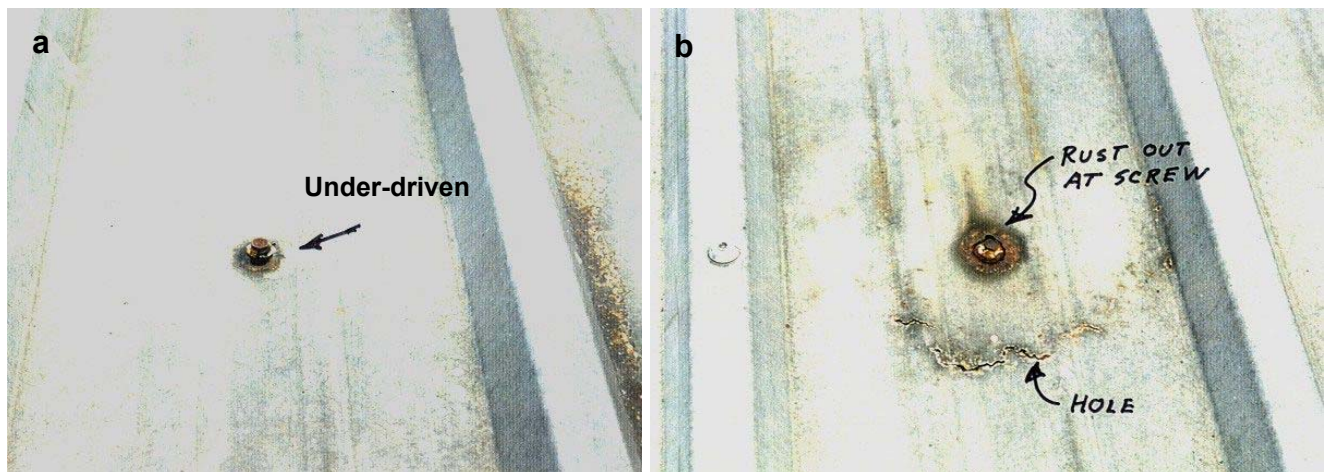
Figure 12. Photographs of under-driven fasteners with water leaking at fastener to cause corrosion at the fastener (a and b), and caused inside-out corrosion due to water saturation of the insulation (b).

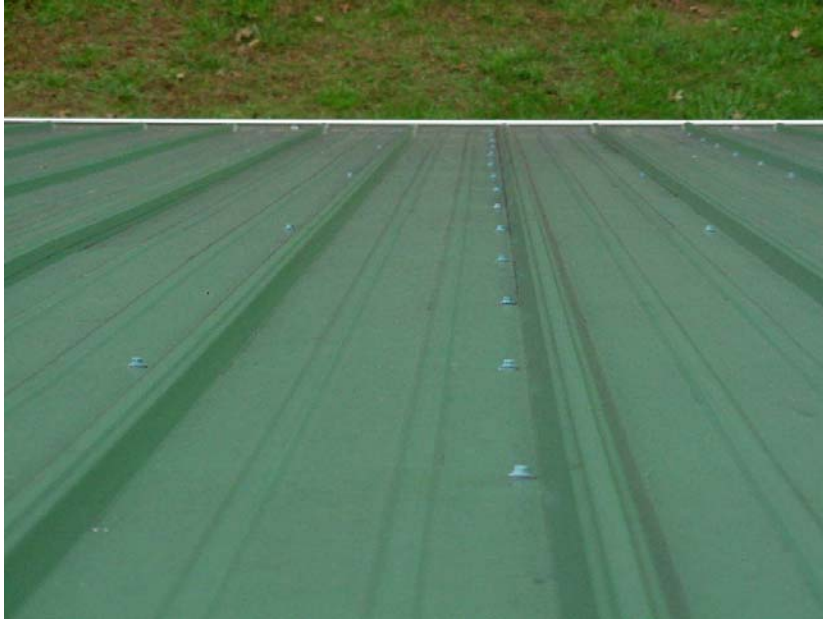
One of the distinctive features of a high slope metal roof is its unique appearance. The choice of the fasteners should match the color and the performance of the roofing panels. Otherwise, the appearance or even the performance of the roof may be adversely affected. Figure 13 shows a green colored prepainted galvanized steel roof with discoloration of the screws. Improper fasteners were used, which resulted in the red rusting of the screws and the discolored appearance of the roof. This problem would not have occurred, if the correct fasteners had been used (Figure 14).

Figure 13. Photograph of the prepainted galvanized steel roof with non-matching screws.

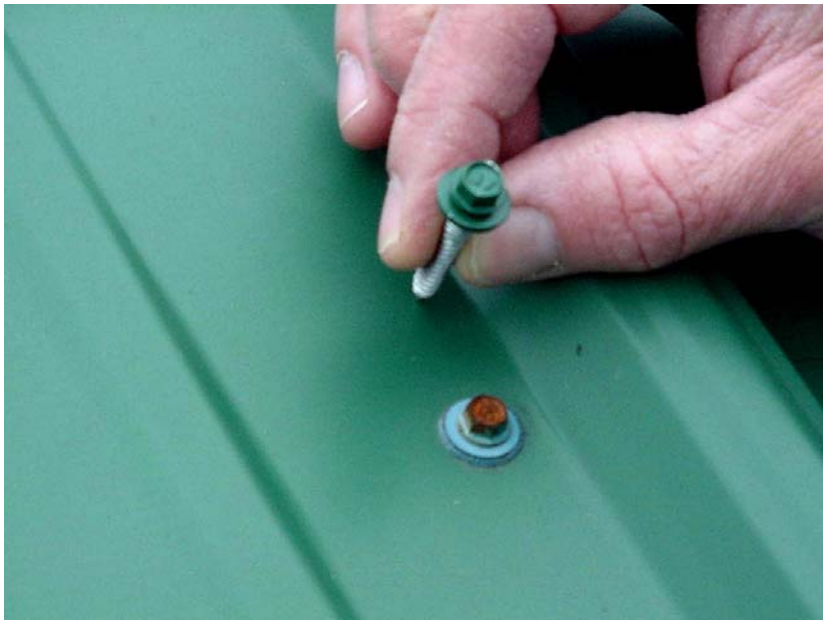
Figure 14. A close view of a non-matching screw with red rust and the correct screw, held in the hand, which should have been used for this application.

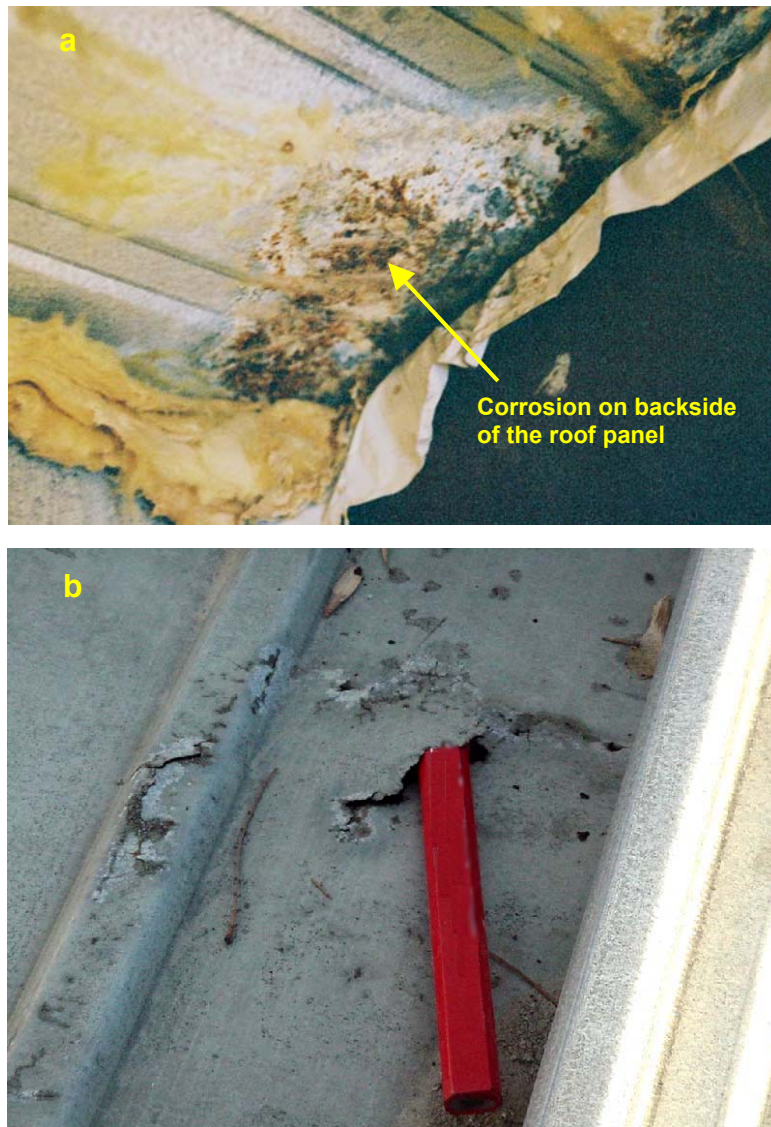
Insulation provides resistance to heat transfer and protects against condensation forming on cold surfaces inside the building or within the wall/roof system cavities. The insulation should have a vapor retarder face on the “warm” side of the insulation. For most buildings, the vapor retarder is on the inside surfaces facing the building interior. The thickness of the insulation must be designed to maintain the temperature of the vapor retarder above the interior dew point under the worst expected outside temperatures. All perimeter conditions and seams must be adequately sealed to avoid moisture penetration of the vapor barrier and provide a continuous membrane to resist the passage of water vapor. Failure to do so could cause wet insulation, which could cause corrosion on the underside of the roof panels (Figure 15a). This corrosion may lead to perforation corrosion from the inside of the roof panels (Figure 15b).

Figure 15. Photographs of roof panel corrosion due to wet insulation. The corrosion of the GALVALUME® panels was observed on the bottom side of the panels after the insulation was removed (a). Perforation corrosion was observed on the topside of the roof panels (b).

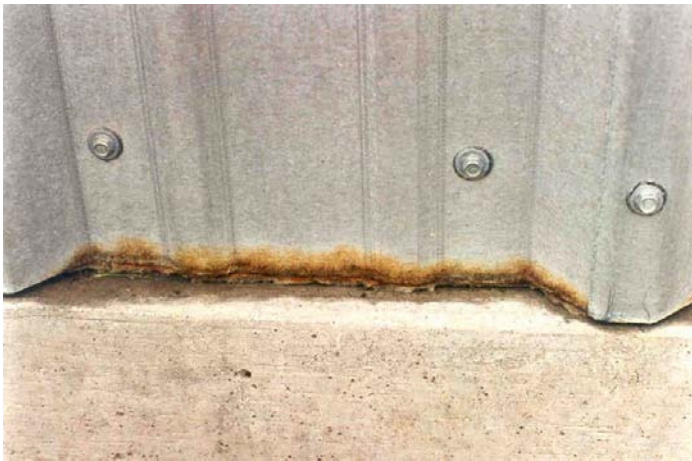
Figure 16 is a classic example of “insulation wicking” causing premature failure of the coated panel. The insulation soaked up the available moisture creating an environment that was always wet causing accelerated corrosion. The contractor should be fully aware that insulation and other building materials that can soak up moisture should not be exposed to the exterior of the building. One solution is to install the insulation at least one inch above the bottom edge of the panels and to fold the insulation face around the bottom edge of the fiberglass (see Figure 17).

Figure 16. Premature corrosion at the bottom edges of the GALVALUME® panel caused by insulation wicking.

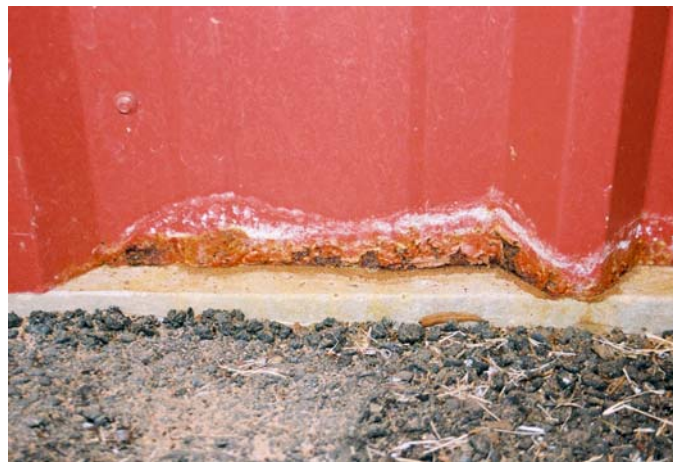
For bare and painted GALVALUME® products, direct contact with cement foundations is not recommended. Accelerated corrosion can occur due to the lime contained in the cement. An example of which with prepainted GALVALUME® siding is shown in Figure 18. Additionally, close proximity to a cement producing facility is not recommended as airborne cement is similarly corrosive to galvanized and GALVALUME® Coated Sheet Steels.

Figure 18. Premature corrosion at the bottom edges of the prepainted GALVALUME® panel caused by direct contact with the concrete foundation.

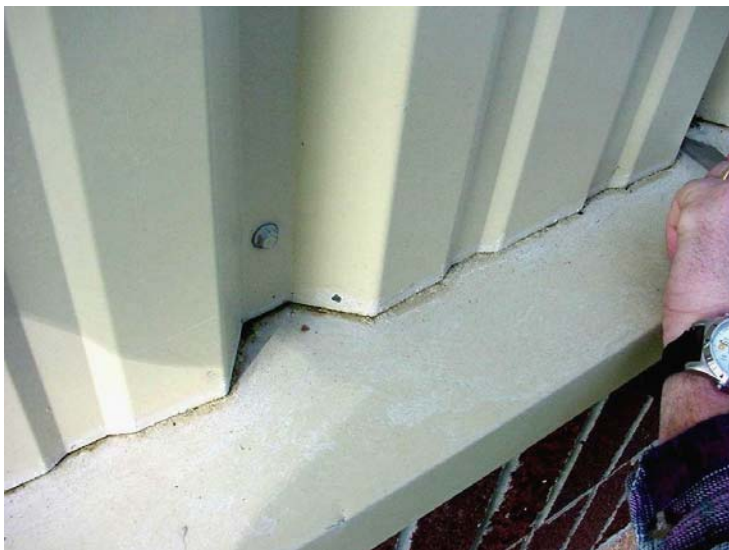
Figure 21 shows premature corrosion on the bottom edge of prepainted GALVALUME® siding where paint blisters and noticeable white residue stain could be observed along the panel edge and on the concrete surface, one year after the installation. This is a typical example of siding installed without flashing on a flat concrete base that does not allow water drainage.

Figure 21. Photograph of premature corrosion on the bottom edge of the siding.

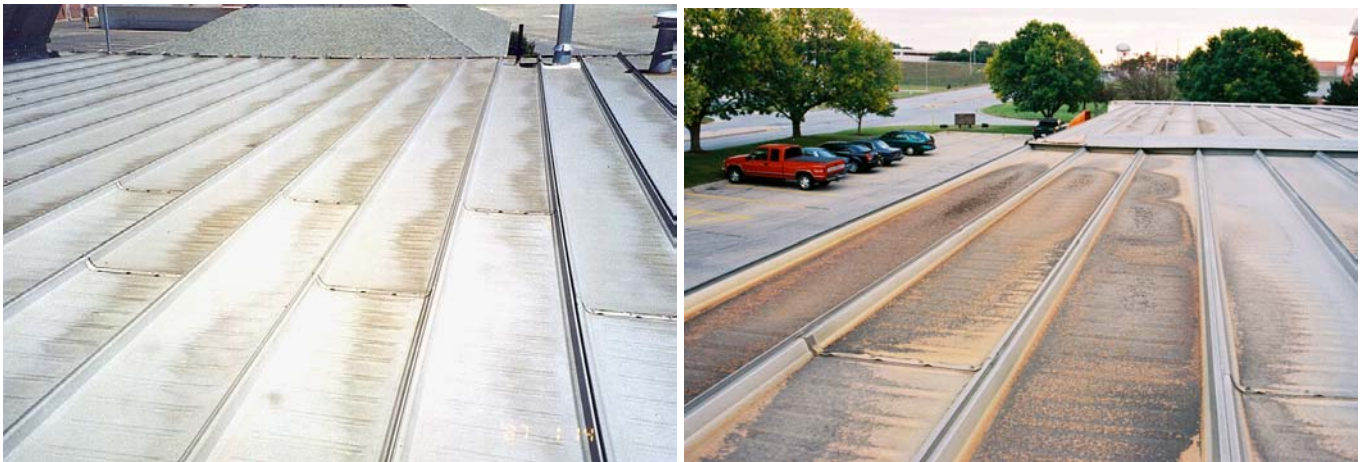
For low slope GALVALUME® roof applications, a minimum slope of 1/4:12 is recommended to provide positive water drainage maximizing the GALVALUME® roof performance. The examples in Figure 22 show standing seam roofs installed with slopes less than the 1/4:12 minimum, which resulted in water ponding in low areas causing corrosion of the metallic coating.

Figure 22. Photographs of water ponding on a GALVALUME® roofs due to improper slope of the roof.

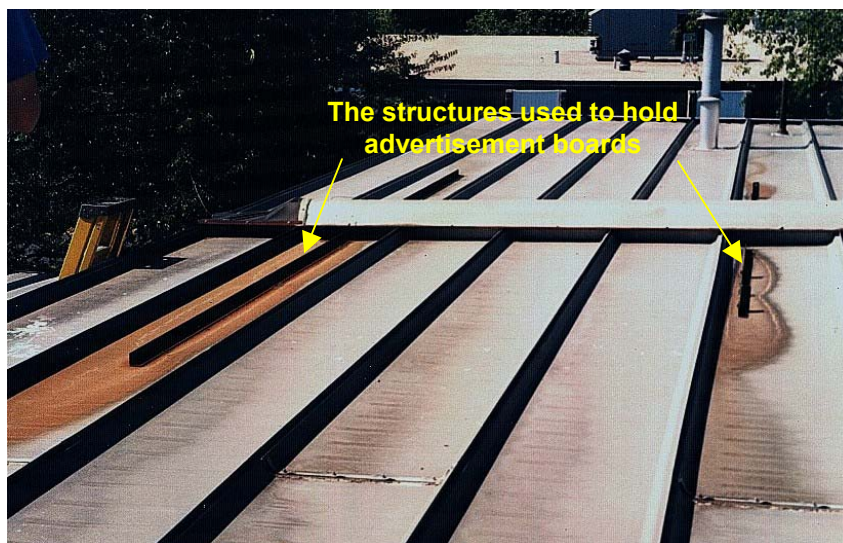
Water ponding may also occur in areas where localized deformation of the roof panels has occurred. The corrosion of the GALVALUME® roof panel in Figure 23 was caused by water ponding at the low spots caused by the weight of advertisement boards that had been positioned on top of the roof.

Figure 23. Photograph of a GALVALUME® roof after 21 years service. The localized corrosion was caused by water ponding at the low spots where the advertisement boards were set on top of the roof.

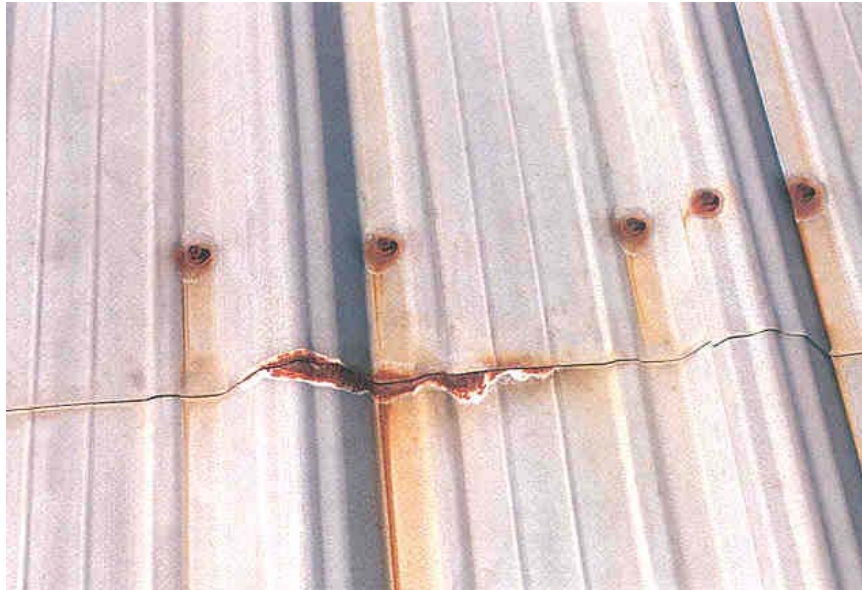
Sealant should be applied at panel end laps to prevent moisture from entering the panel lap joints and causing premature corrosion. Figure 24 <sup>5</sup> shows the crevice corrosion caused by poor end lap sealing on a GALVALUME® roof. Figure 25 shows the paint blistering on a prepainted GALVALUME® roof caused by poor end lap sealing.

Figure 24. Crevice corrosion caused by poor end lap sealing on a GALVALUME® roof.

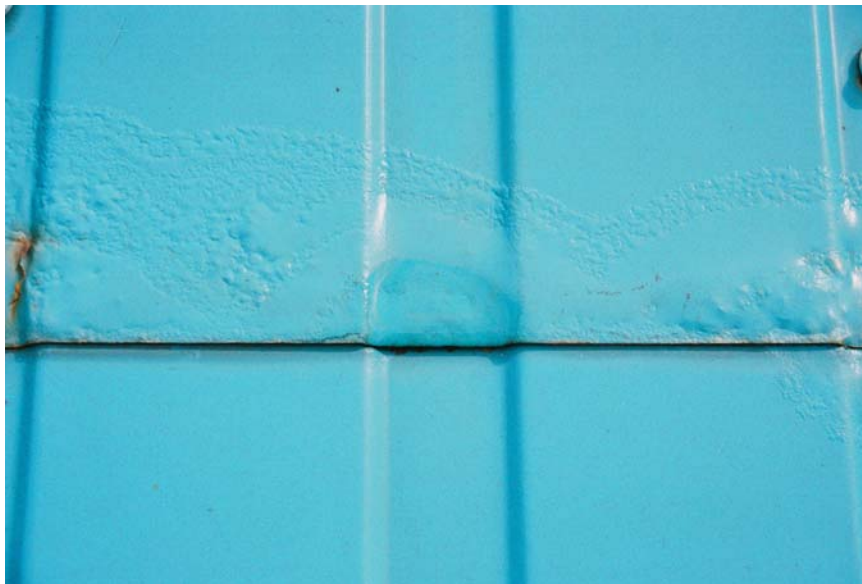
Figure 25. Paint blistering on a prepainted GALVALUME® roof caused by poor end lap sealing.

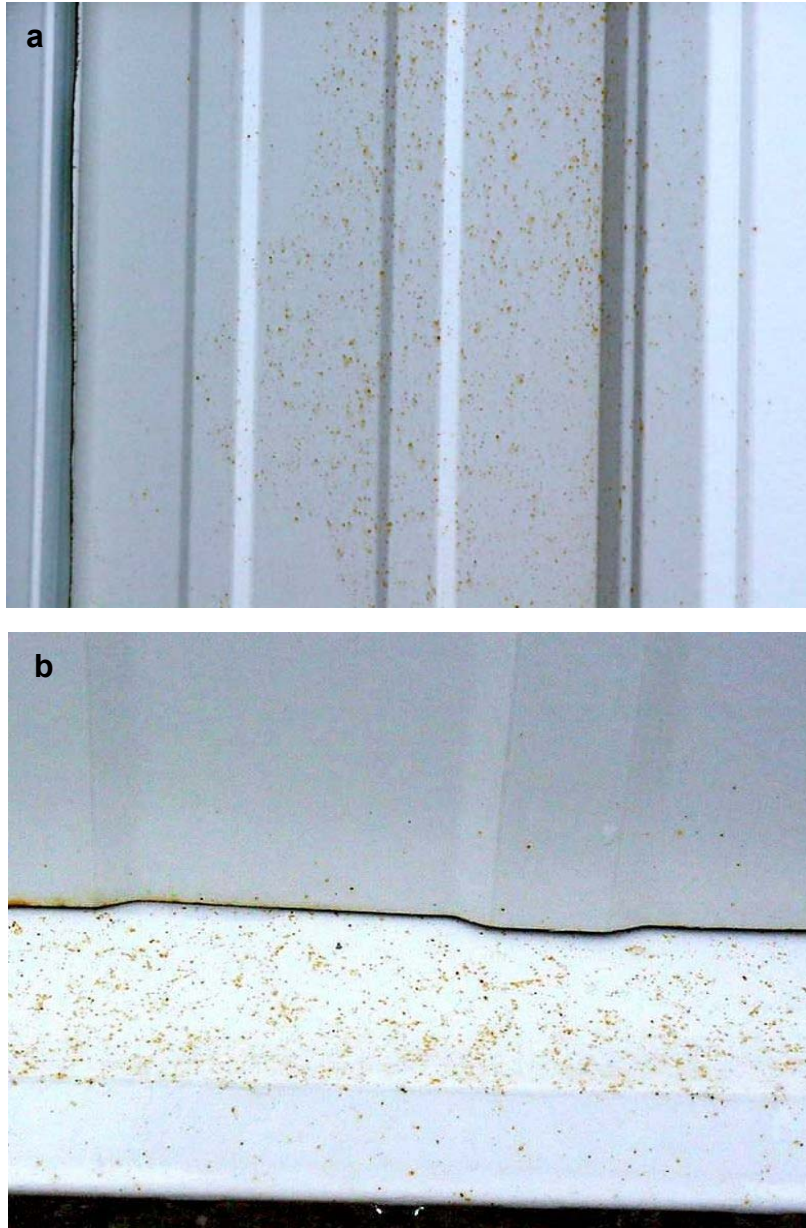
Metal debris from sawing, drilling and other construction processes should be removed during installation. Otherwise, the metal filings will red rust on the surfaces where they were deposited. Red rust of the metal filings may cause stain or discoloration on the surface of the panel whether it is bare or painted and cause appearance issues. Contractors should be cautioned about the importance of removing any debris generated during installation. Cutting and drilling should be done on the backside of the panels in order to avoid damaging the exposed surface with hot metallic particles. Figure 26 shows red rusted metal filings and the stains on a prepainted siding panel and on the concrete base at the bottom of the siding.

Figure 26. Photographs of red rusted metal filings and the stains on a prepainted siding panel (a) and on the concrete base at the bottom of the siding (b).

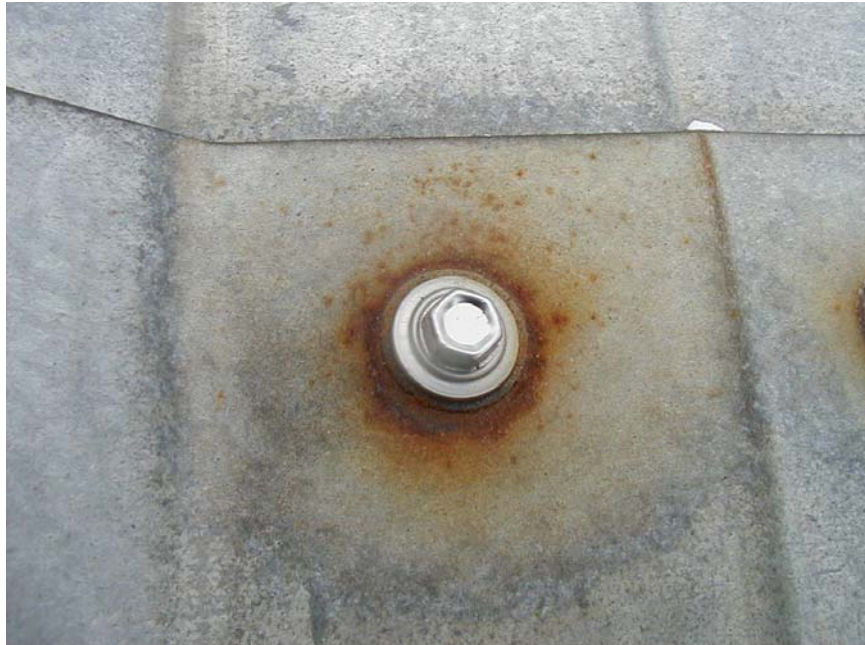
Figure 27 shows the red rusted metal filings on the surface of a bare GALVALUME® roof panel around a screw due to failure to remove the metal fines from drilling. Figure 28 shows another example of not removing metal filings after drilling screw holes on a prepainted GALVALUME® roof panel. Care must be taken to minimize the contact of hot metal filings from self-drilling or self-tapping screws with the coated panel surface. Any metal filings remaining on the panel surface must be removed at the end of each workday. Otherwise, those fine metal particles will corrode and result in rust staining on the panel surface.

Figure 27. Photograph of red rusted metal filings on the surface of bare GALVALUME® roof panel around a screw.

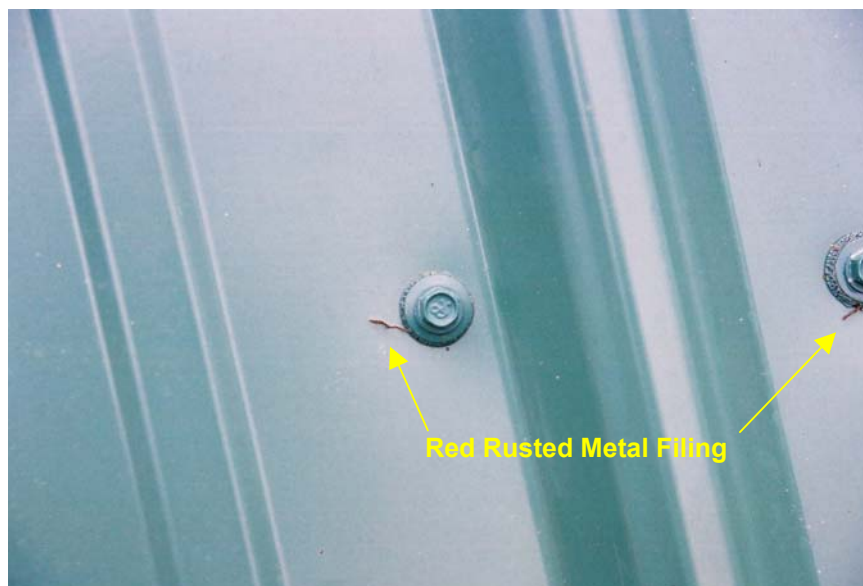
Figure 28. Photograph of red rusted metal filings from the screws on a prepainted GALVALUME® roof panel.

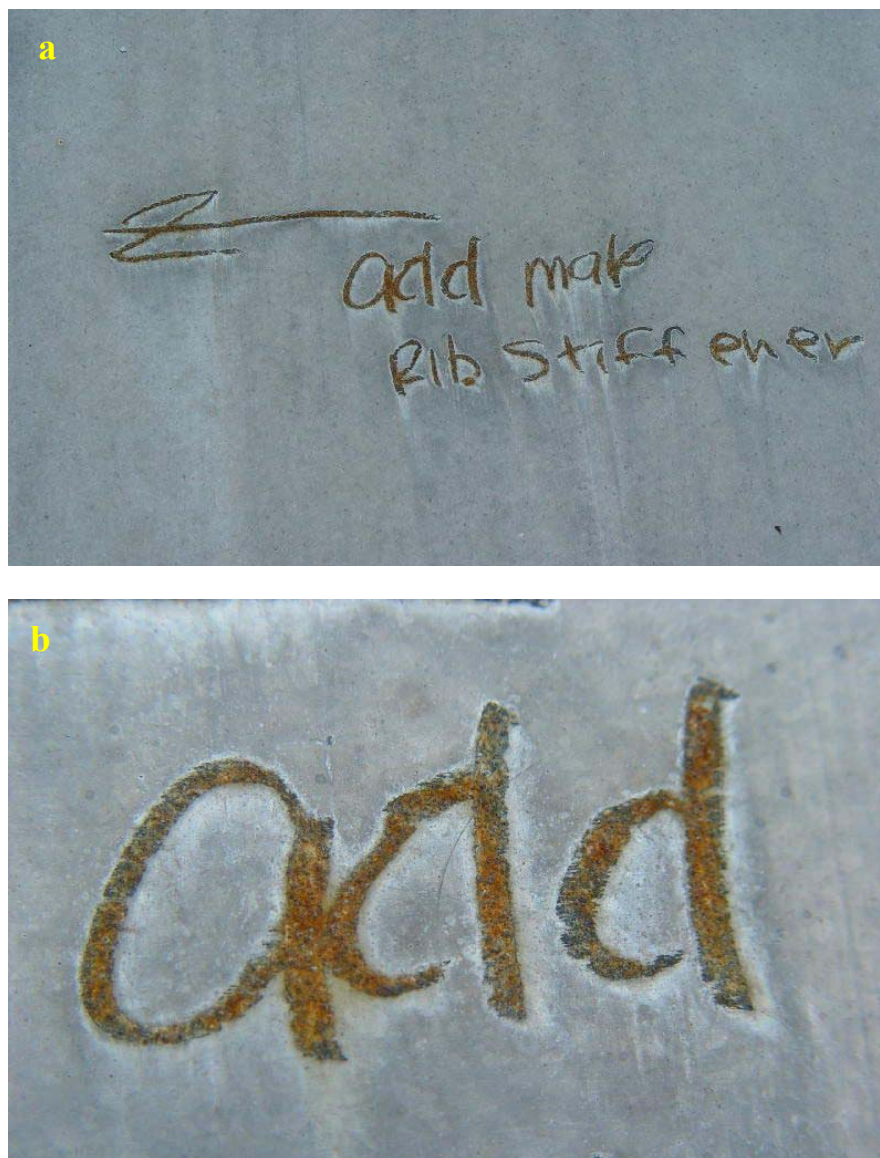
Pencil is made of graphite. When a pencil is used to write on galvanized steel it leaves graphite powder on the surface. Figure 29 is an example of pencil mark corrosion on galvanized steel sheet. Pencil mark corrosion is a form of galvanic corrosion. Because graphite is electrochemically very noble, 3 to 4 volts more noble than the zinc, a strong galvanic cell is created and the zinc on or adjacent to the pencil mark rapidly corrodes. The open circuit potential of graphite is cathodic to all metals and alloys in most aqueous environments. One should never write on galvanized steel with a pencil.

Figure 29. Photographs of pencil mark corrosion on galvanized steel sheet (a), and a magnified view of the mark (b).

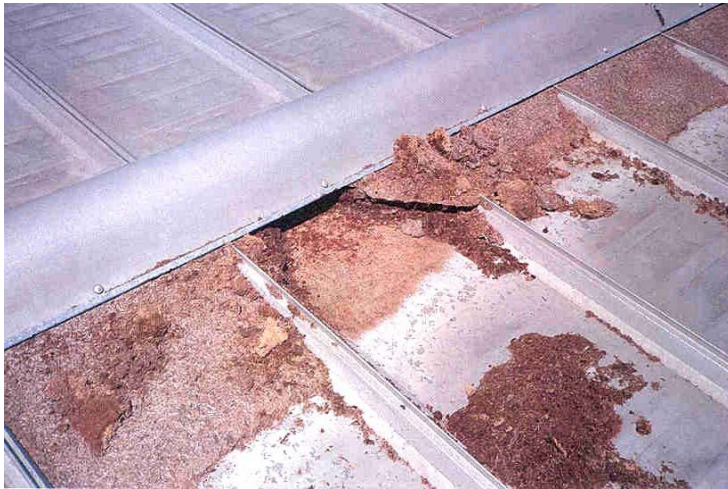
Debris should be removed from the metal roof during or following installation and through regular roof maintenance because debris can cause staining and premature corrosion. Figure 30<sup>6</sup> shows wood chip debris piled near the ridge cap that caused heavy corrosion of roof panel due to water being retained by the debris. Figure 31<sup>6</sup> shows that the corrosion occurred under the treated lumber because chemicals, particularly copper compounds, leached from the wood accelerating the corrosion. Figure 32 is another example; a piece of metal tube left on the roof caused staining and corrosion of the roof panel.

Figure 30. The wood chip debris piled near the ridge cap caused heavy corrosion of the roof panel due to water being retained by the debris.

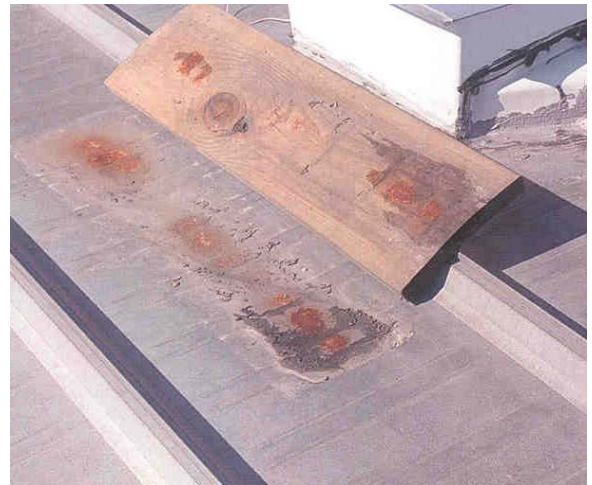
Figure 31. Corrosion occurred under the treated lumber because chemicals, particularly copper compounds, leached from the wood accelerating the corrosion.

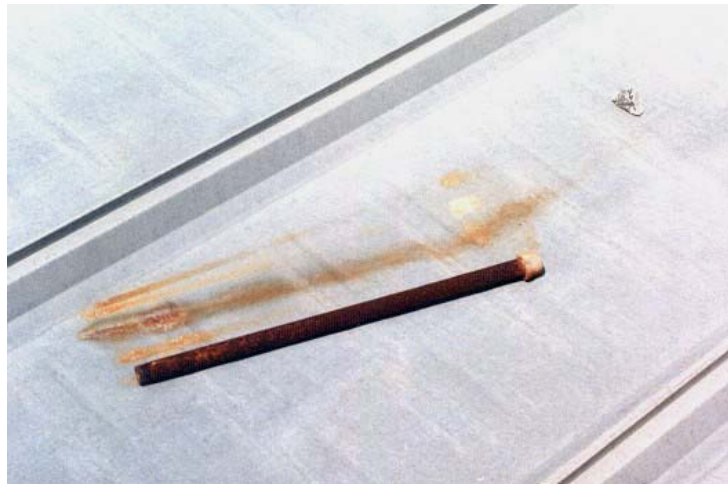
Figure 32. A piece of metal tube left on the roof caused staining and corrosion of the roof panel.

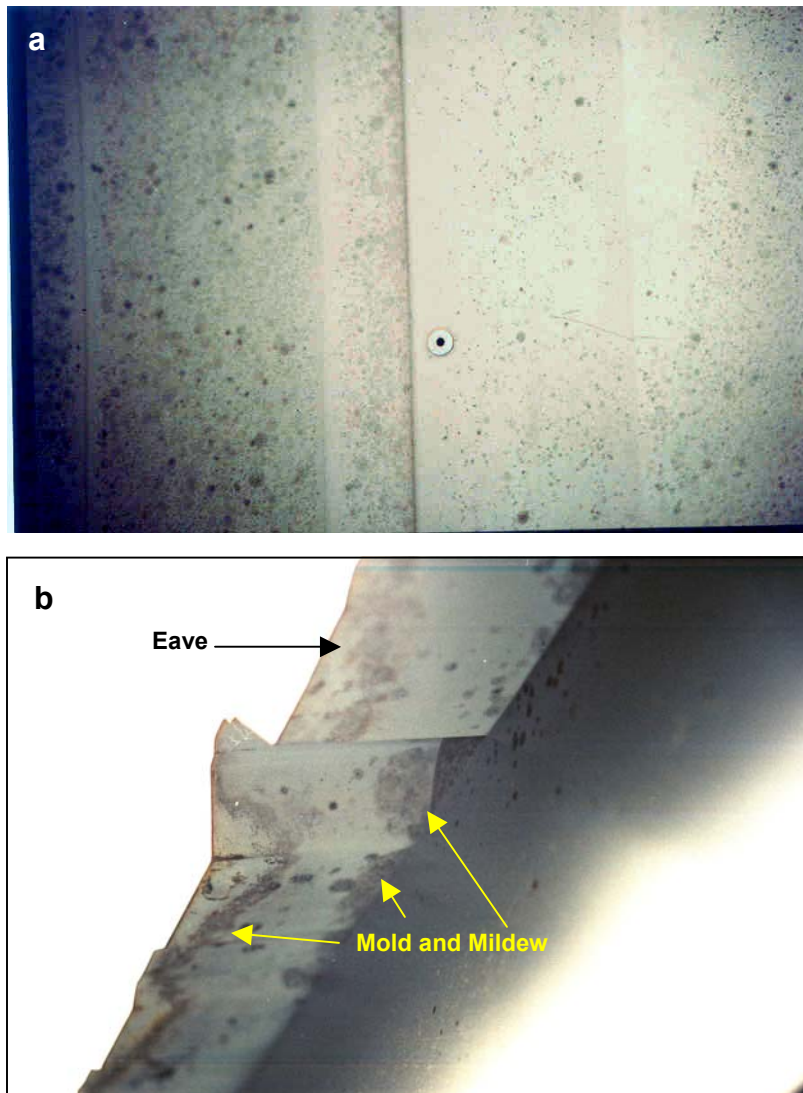
The photographs in Figure 33 show a green/brown appearance of mold or mildew on painted side wall panels and on the under side of the eave, which could cause staining on the surface. This is considered a maintenance issue. Proper ventilation and periodic cleaning should reduce the impact of mold and mildew. Remove mildew by wiping or by using a power spray. Then wash the area with an antiseptic cleaner such as bleach. Rinse the area thoroughly.

Figure 33. Mold or mildew buildup on painted side wall panel (a) and on the under side of the eave (b) where the building was surrounded by a woody area and constantly exposed to a high humidity environment.
