United States Steel Corporation

# **Resolution Manual For Metal Building Construction**

## **Job Site Imperfections**

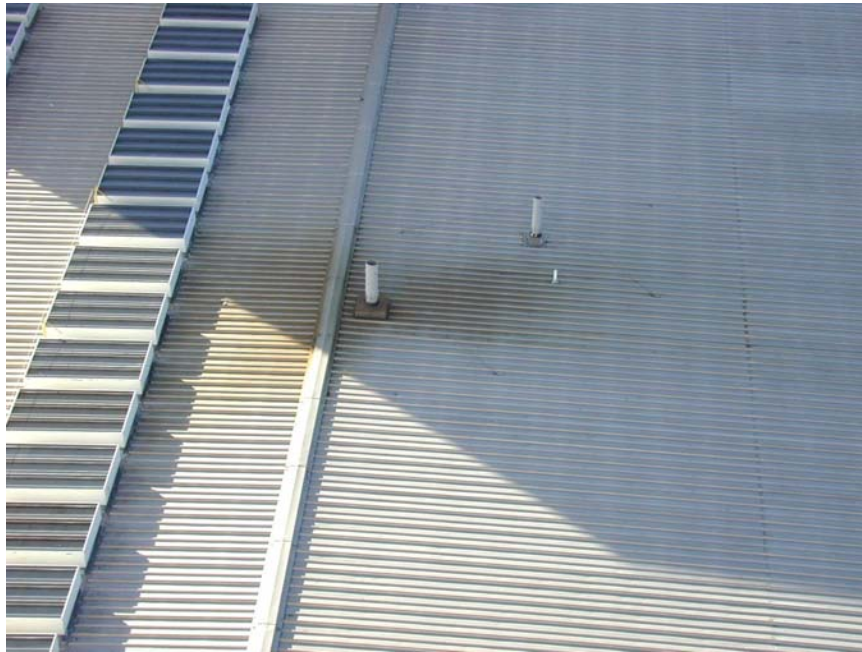
Exhausts discharged through roof stacks can sometimes create corrosive environments around them. The roof panels should be inspected periodically. The panels around exhausts can be coated with recommended maintenance paints, if it is necessary. Figure 34 shows a bare GALVALUME® roof corroded around the vent from a laboratory where acid was constantly used. Figure 35<sup>7</sup> shows that the GALVALUME® roof around the roof stacks was corroded after 20 years due to the exhaust from a space heater.

Figure 34. The bare GALVALUME® roof was corroded around the laboratory vent.

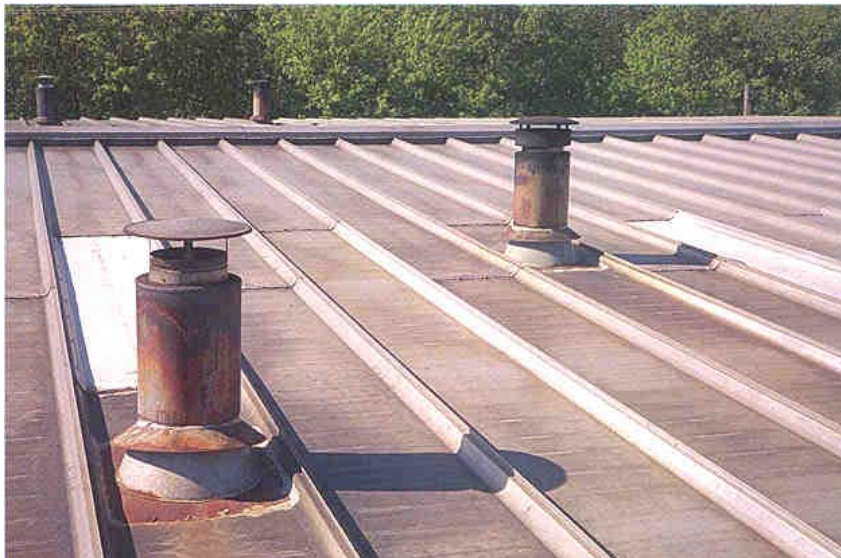
Figure 35. The GALVALUME® roof was corroded around the roof stacks.

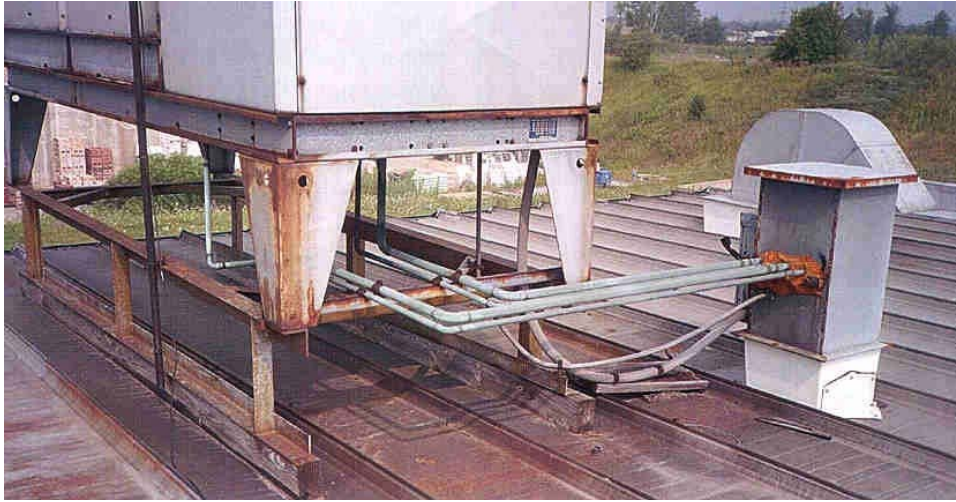
Galvanized and GALVALUME<sup>®</sup> panels should not be in contact with, or subject to, water runoff from copper, lead, or uncoated steel materials. Condensation water from air conditioning units typically contains dissolved copper, which should be discharged through a plastic pipe extended beyond the edge of the roof. The effect of the condensation water runoff from the copper piping on the GALVALUME<sup>®</sup> panels is significant in both outdoor and indoor situations, such as shown in Figure 36<sup>8</sup> and in Figure 37.

Figure 36. GALVALUME<sup>®</sup> roof panel corrosion due to condensation water runoff from the copper pipes.

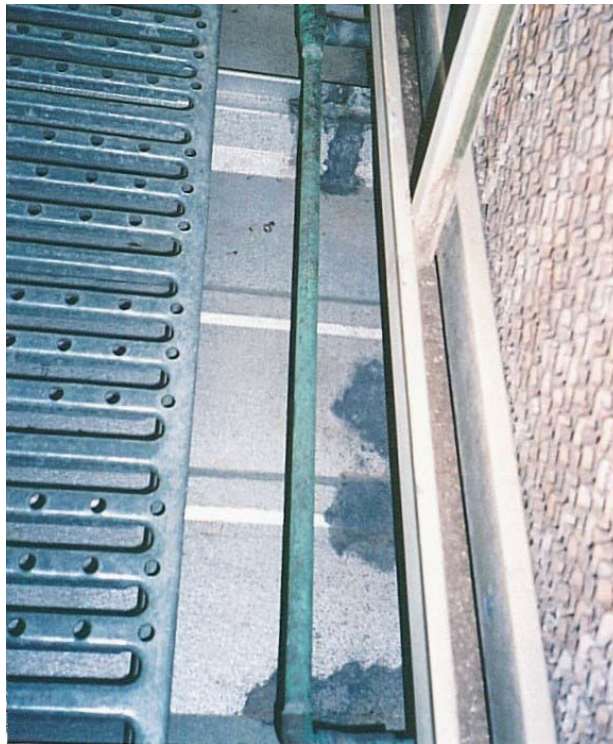
Figure 37. GALVALUME<sup>®</sup> panel corrosion due to condensation water runoff from the copper pipes.

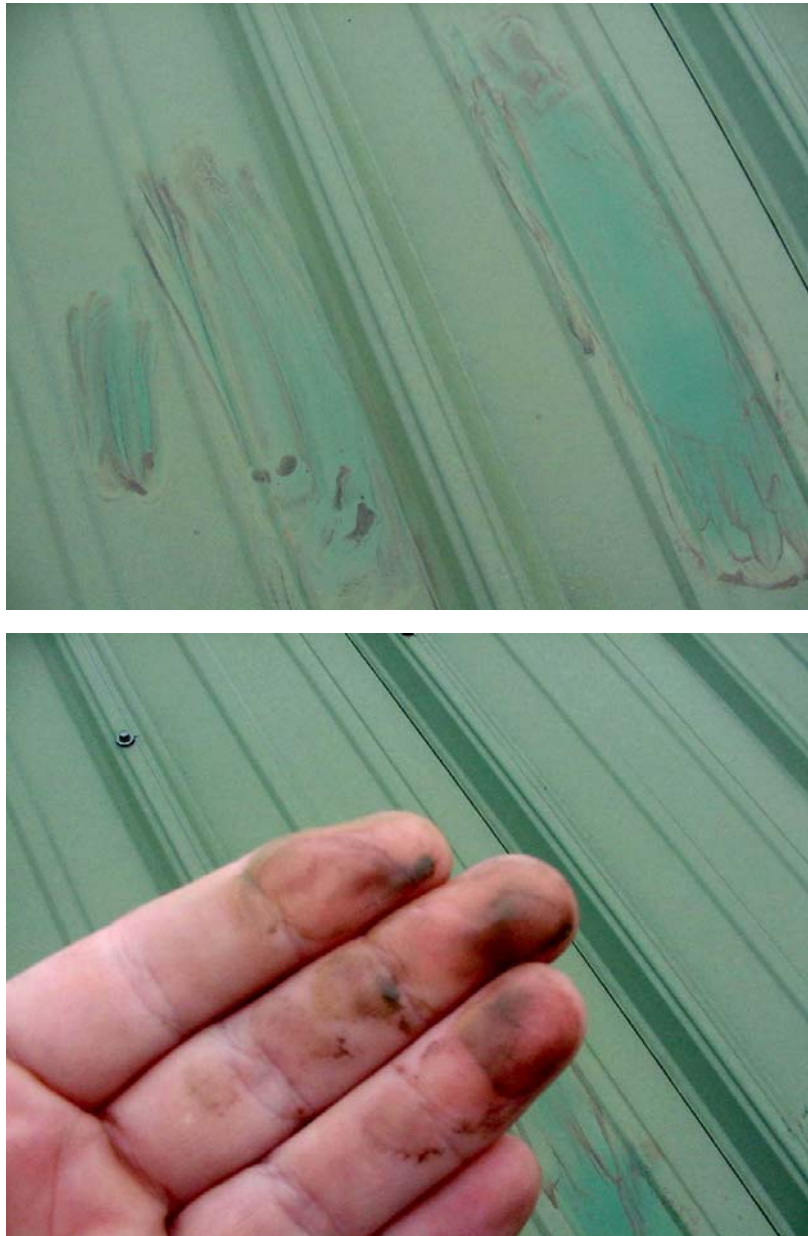
Two types of dirt accumulate on buildings: dry soil and greasy or organic residues. The dry dirt, by itself, washes off with rain or high-pressure water spray. Greasy residues do not wash off in rain and hold dry soil and chalk tightly to the surface. These residues originate from automobile exhaust, fireplaces, ventilation fan oil, pesticides, and various other common sources. This is the kind of dirt that requires cleaners for removal. Detergents, ammoniated cleaners and solvents are particularly effective in removing this greasy kind of dirt. Generally, lighter colors show dirt more than dark colors. However, dirt remaining on a darker roof can also cause discoloration, an example of which is shown in Figure 38. The bright color has been covered by dirt.

Figure 38. The prepainted GALVALUME<sup>®</sup> roof panel discoloration is due to dirt coverage.

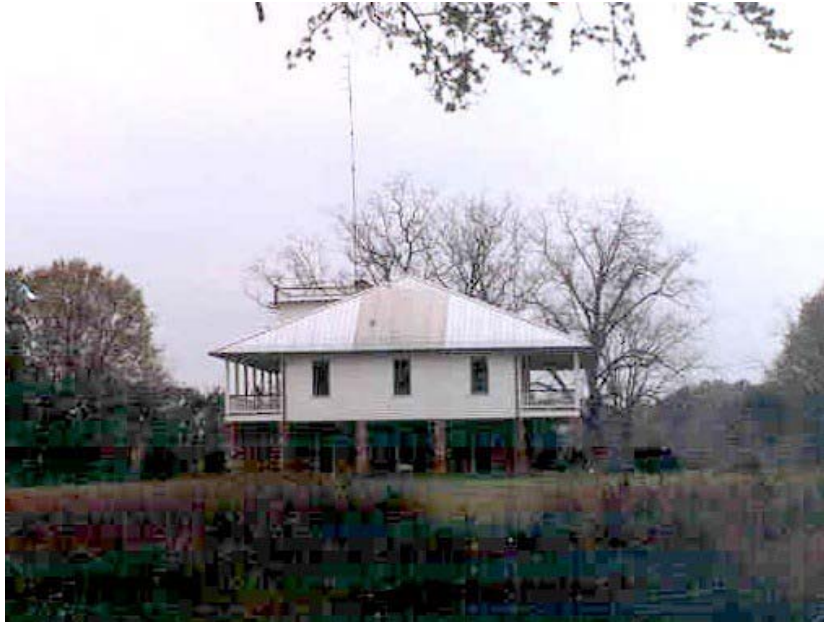
Bare GALVALUME® Coated Sheet Steel is not recommended for high visibility applications, such as the high slope roofing application shown in Figure 39, because of the potential for differential darkening. The darkening variation can be minimized by supplying material from one supplier and from one master coil. Consecutive master coils supplied by the steel mill will also reduce, but not eliminate the possibility of variation. The darkening variation may also be observed on ACRYLUME® Coated Sheet Steel panels (Figure 40). Therefore, if the application requires a consistent surface appearance, a painted product is recommended.

Figure 39. Differential darkening of bare GALVALUME® panels on a high slope roofing application.

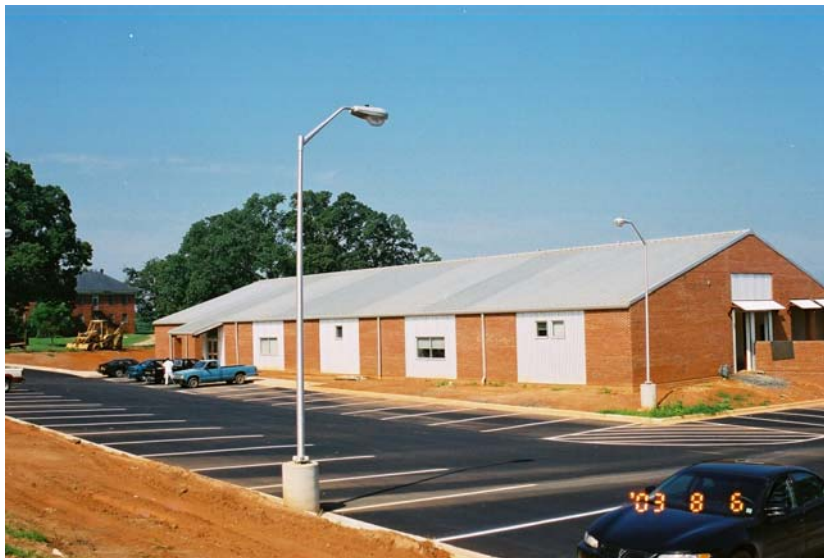
Figure 40. Differential darkening of ACRYLUME® panels on a high-slope roofing application.

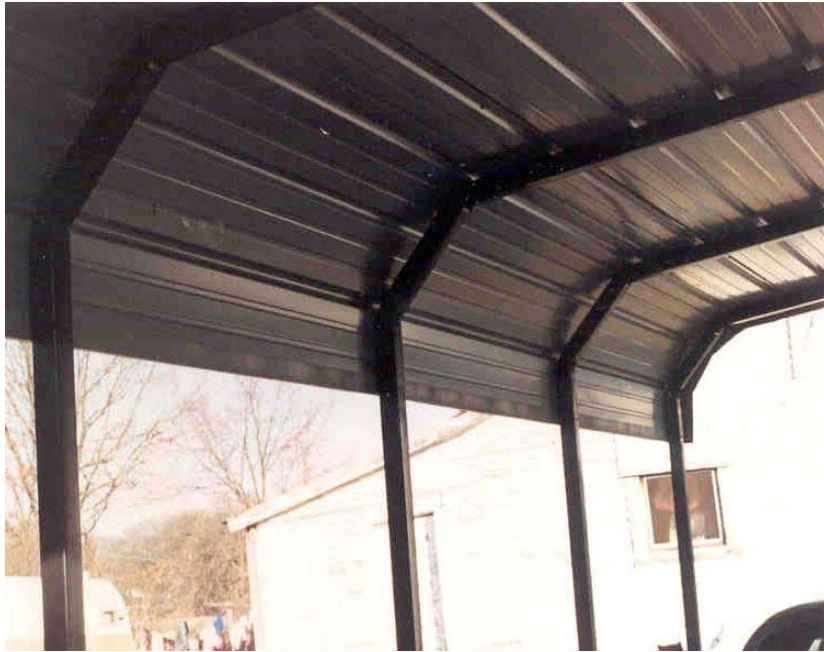
The design of metal roofing should allow water runoff and also provide adequate ventilation to prevent condensation. An improper design will affect the corrosion performance of the roofing panels whether they are bare or painted. The roof design shown in Figure 41 does not allow rainwater to runoff along the curvature of the roof, causing condensation to accumulate on the backside of the panel along the ribs (Figure 42). Contractors should be warned of the potential impact of such applications and designs, which do not allow effective water runoff or proper ventilation.

Figure 41. Improper roof profile design of a pole building with open sides does not allow rainwater to runoff along the curvature of the roof.

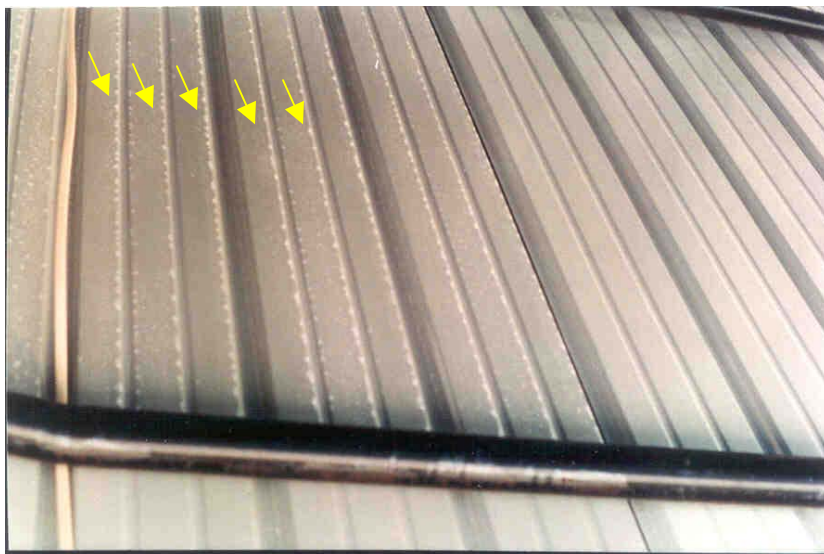
Figure 42. Photograph of the backside of the roofing panel shows condensation accumulating along the ribs of the panel as the arrows indicate.

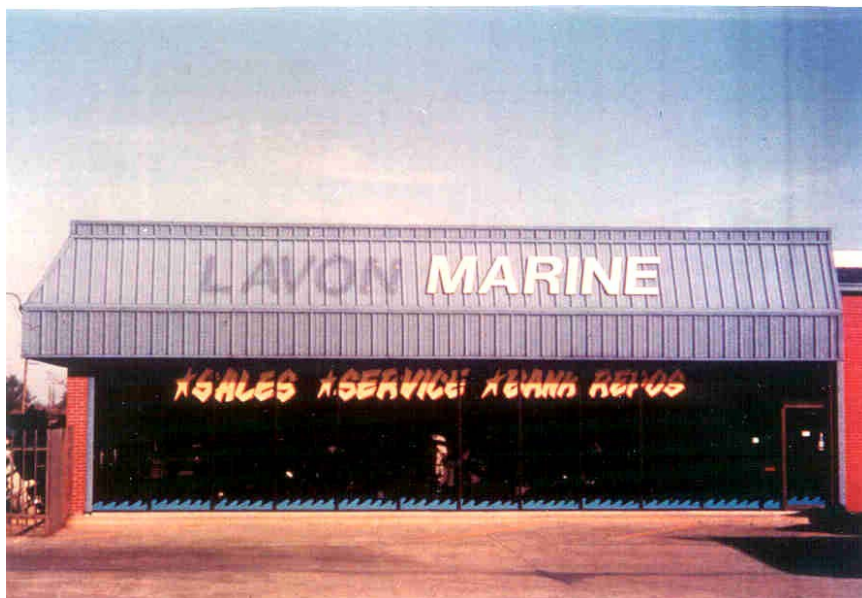
Fading is typically caused by the breakdown of the components of the paint film by UV light from the sun. Paint suppliers indicate the degree of fading that can normally be expected from a particular paint system over a given time period. An area that is blocked from the UV exposure will have less fading than areas exposed to the sun. An example of this is shown on the building in Figure 43. In the case of non-uniform fading of the paint, such as the prepainted roof in Figure 44, there are noticeable differences in color between one section and another section of the roof panels. The amount of fade should be evaluated by the representatives of the coil coater or paint supplier to determine the cause.

Figure 43. Color fading of the paint on prepainted panels due to UV light from the sun.

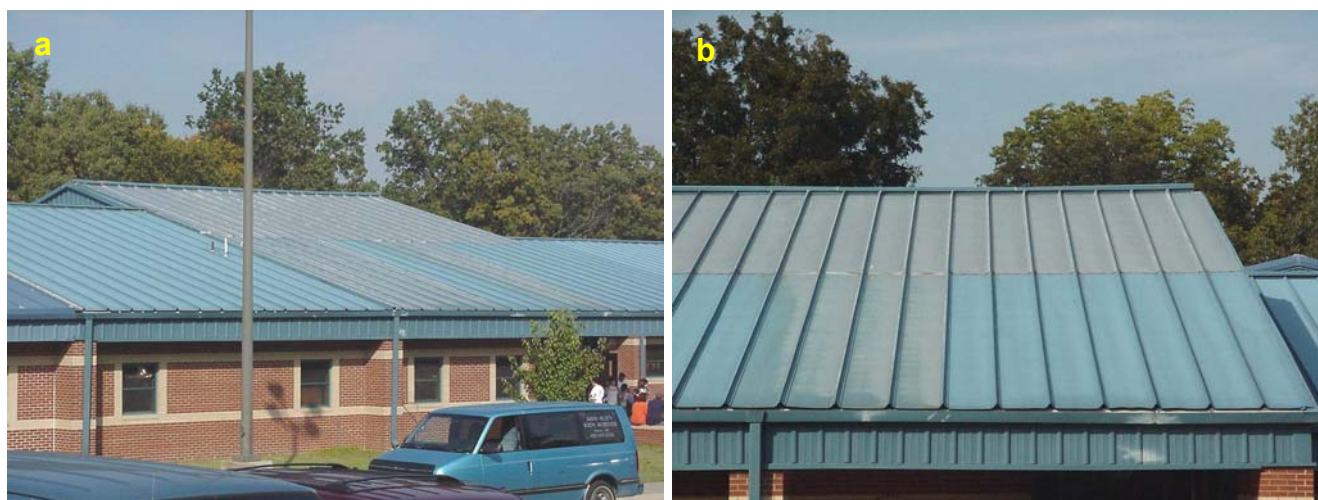
Figure 44. Non-uniform fading of a prepainted roof with noticeable differences in color from one section to another section (a) and its close look (b).

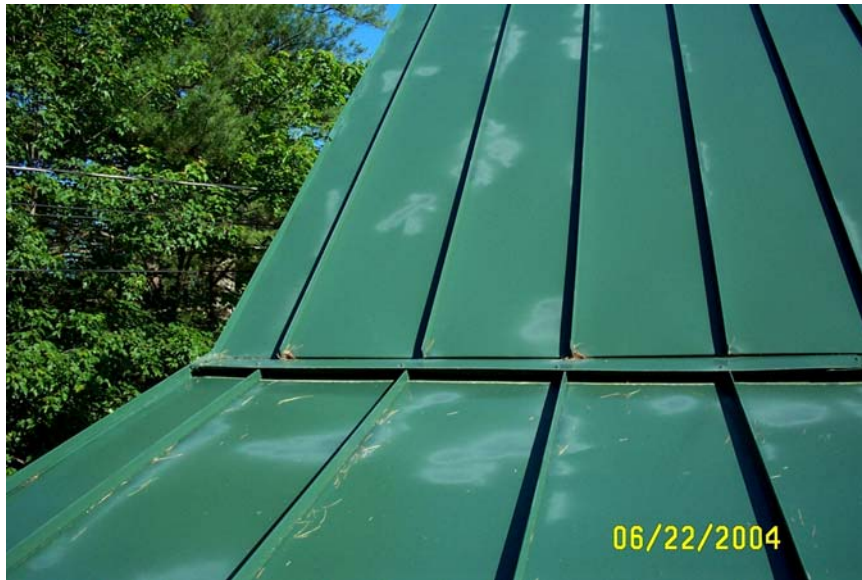
Touch-up paint is often used to repair or cover the scratches, abrasion marks or other lightly damaged areas on prepainted building panels. Appropriate touch-up paints, normally supplied by the paint manufacturers, will match the colors and meet the performance requirements with the paint on the building panels. If unsuitable touch-up paint is used, it may cause differential chalking and fading appearance on the painted panel, which may require repainting of the entire affected surface. The pictures below demonstrate the poor performance of improper touch-up repair paints, which have caused differential chalking and fading appearance on the prepainted GALVALUME® steel roof (Figure 45) and on the prepainted hot-dip galvanized steel siding (Figure 46).

Figure 45. Differential chalking and fading appearance on the prepainted GALVALUME® steel roof with improper touch-up paint.

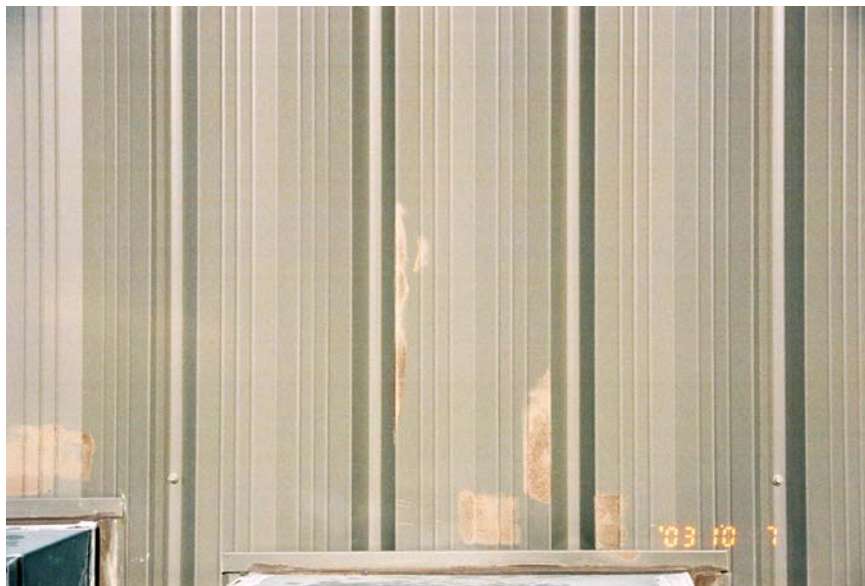
Figure 46. Differential chalking and fading appearance on prepainted hot-dip galvanized steel siding with improper touch-up paint.

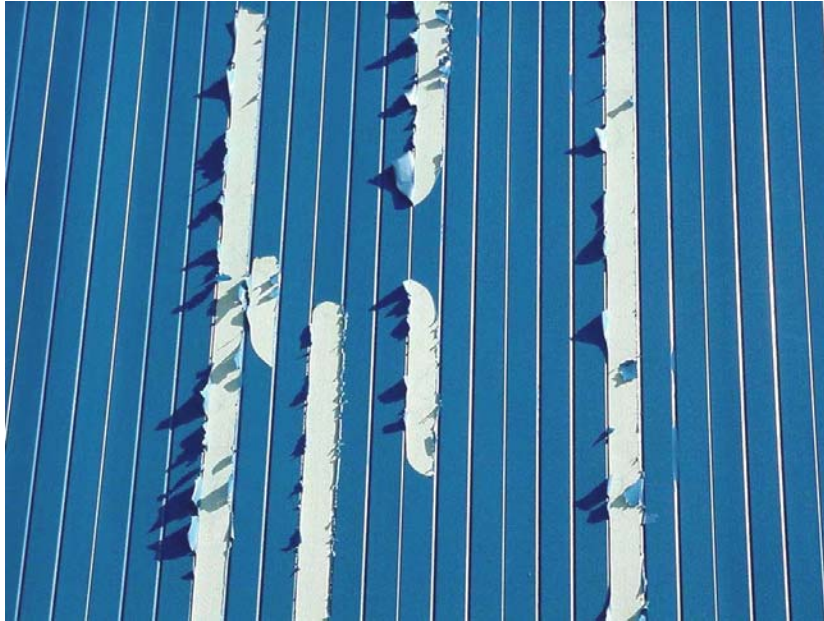
Generally, paint systems for exterior building panel applications consist of a primer and a topcoat. The primer should provide good adhesion to the coated steel substrate and to the topcoat. Figures 47 to 49 show an example of inter-coat adhesion failure of the paint where the topcoat has delaminated from the primer on the prepainted GALVALUME® Coated Sheet Steel. The primer still remains on the surface of the coated steel sheet substrate (Figure 49). In this case, the failure is not related to the GALVALUME® Coated Sheet Steel. The coil coater and paint supplier should be contacted to resolve this issue.

Figure 47. Inter-coat adhesion failure on a prepainted GALVALUME® panel.

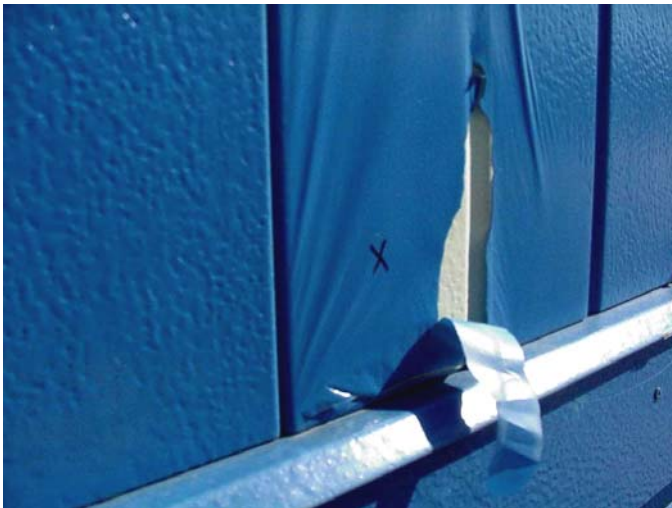
Figure 48. The topcoat delaminated from the primer.

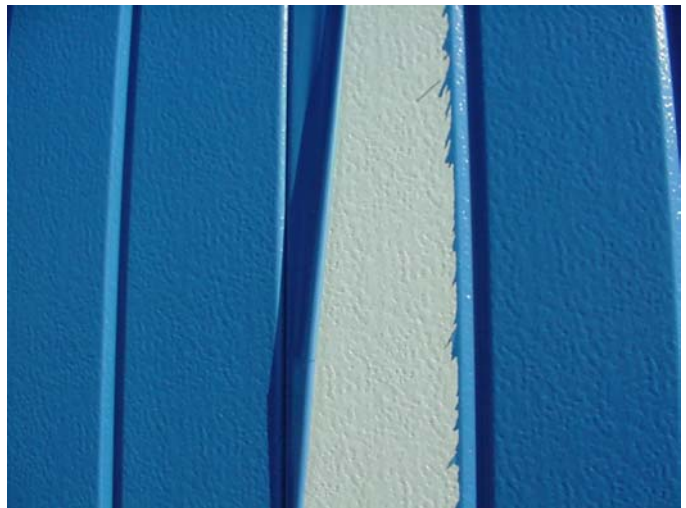
Figure 49. The primer remained on the panel where the topcoat peeled off.
